# Care and Maintenance of Circulating Fluidized Bed Boilers Refractory Failure

By Kurt Knitter  
Power Generation Consultant  
Eighth Street Services LLC

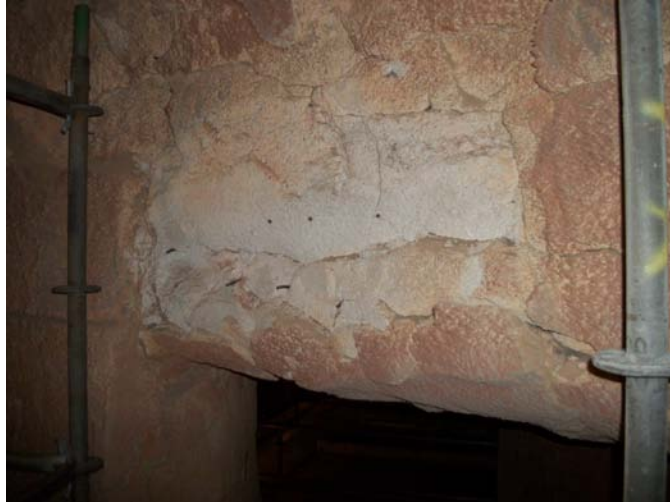
Figure 1

General cracking in "gunned" material  
in cyclone above cyclone inlet.  
Typical thermally induced cracking.

Although some degree of thermally induced cracking and spalling is inevitable the severity of these can be greatly reduced by following acceptable heat up and cool down curves. These curves are generally supplied by the original equipment manufacturer (OEM) but may be obtained from a reputable refractory vendor. Adequate provision for uninhibited expansion and contraction must be considered prior to installation of any significant refractory repairs or new installations. Proper consideration for expansion joints is a must during installation of refractory.

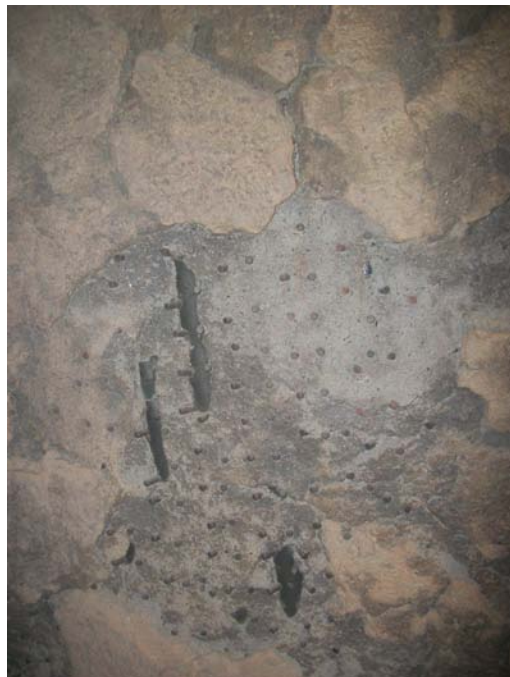
Figure 2

Spalling of refractory from water wall tubes  
in combustor bed area.  
Typical thermally induced Spalling.

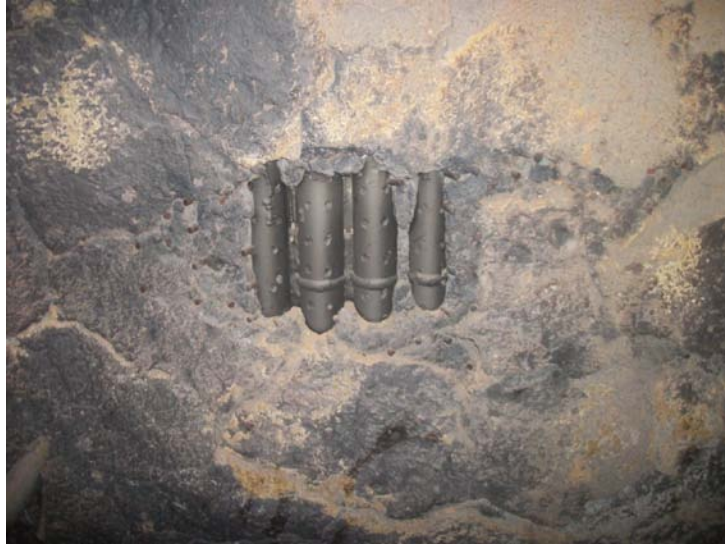
Figure 3

Failure of Stud to Water Wall Tube Weldment Resulted in failure of refractory at this site.

Improper attachment welds may also lead to anchor system failure. Poor electrode selection, improper weld procedure selection, or improper welding technique may lead to detachment of the anchor from the wall, roof, etc. resulting in refractory failure. Anchoring systems must be attached to roofs, walls, etc., with sound weldments.

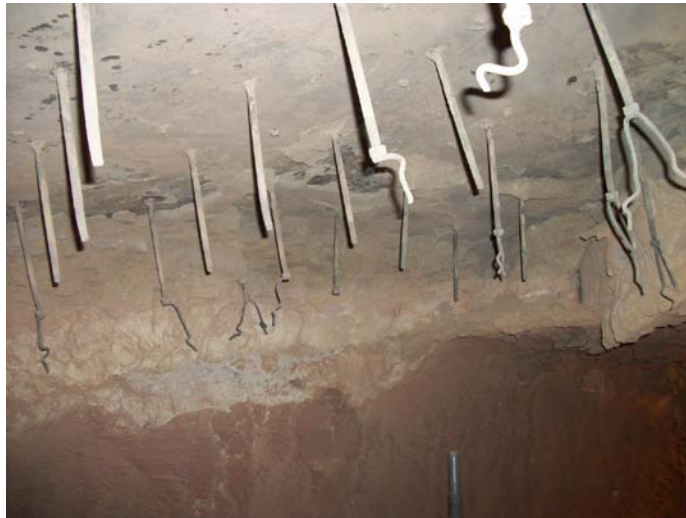
Figure 4

Failure of "Pant legs" on "Dancing Lady" Anchors. Failure resulted in significant refractory failure. Anchors shown after refractory removed.

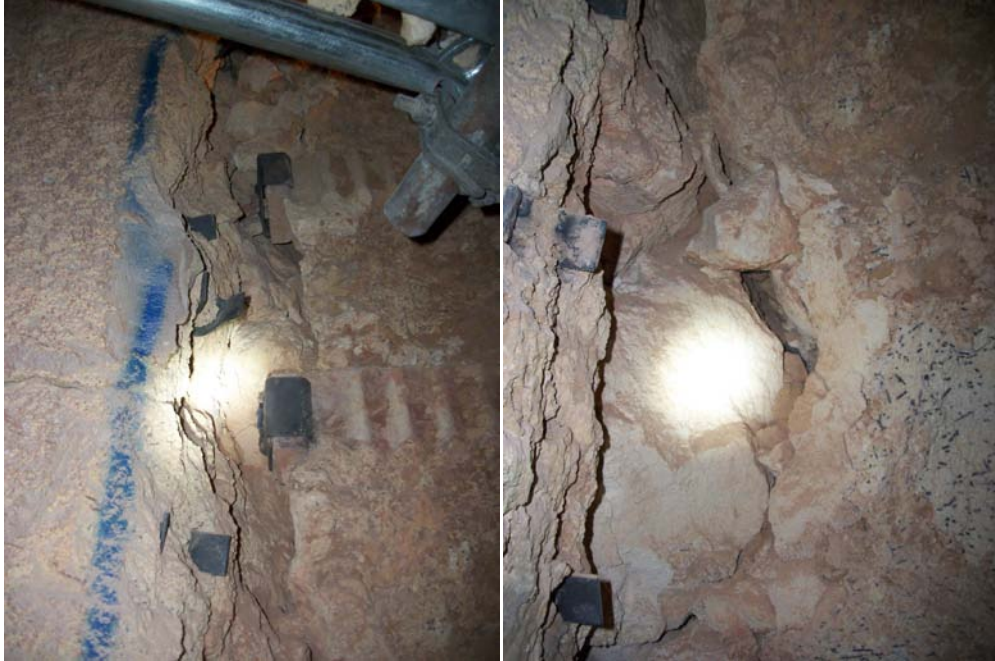
Figures 5 & 6

Severe cracking in cyclone "bull nose" refractory due to failure of anchoring system. Improper anchors standoff material used (carbon steel).

Poor anchor design (material choice, configuration, etc.) for the application may also lead to failure of the anchors. Anchoring system in CFB units can be subjected to upwards of 1800oF during operation of the units. If an improper material is selected for high temperature service, such as carbon steel, is used for the anchor material, the anchor is sure to fail due to detrimental microstructure changes and accelerated corrosion at the high temperatures. Anchor system must be fabricated from heat and corrosion resistant materials based on the application.

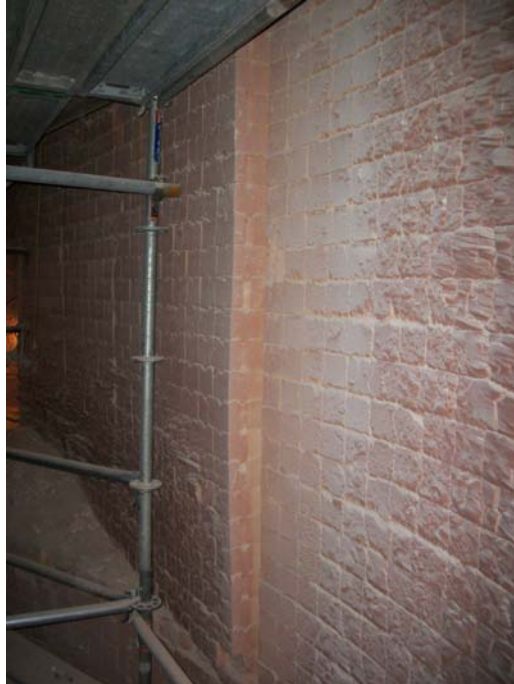
Figure 8

Cyclone inlet "long wall" shifted out of plane approximately 4" due to failure of brick anchors. Entire wall will have to be replaced.
